**EAGLE RIVER TRAINING CAMP
PRELIMINARY ASSESSMENT TRIP REPORT
Eagle River, Alaska**

TDD: 97-02-0010

TRIP REPORT

DATE: August 15, 1997
TO: Mark Ader, Task Monitor, EPA, Mail Stop ECL-115
FROM: Michael Daigneault, Project Manager, E&E, Anchorage, AK
SUBJ: Eagle River Training Camp Site
REF: TDD 97-02-0010

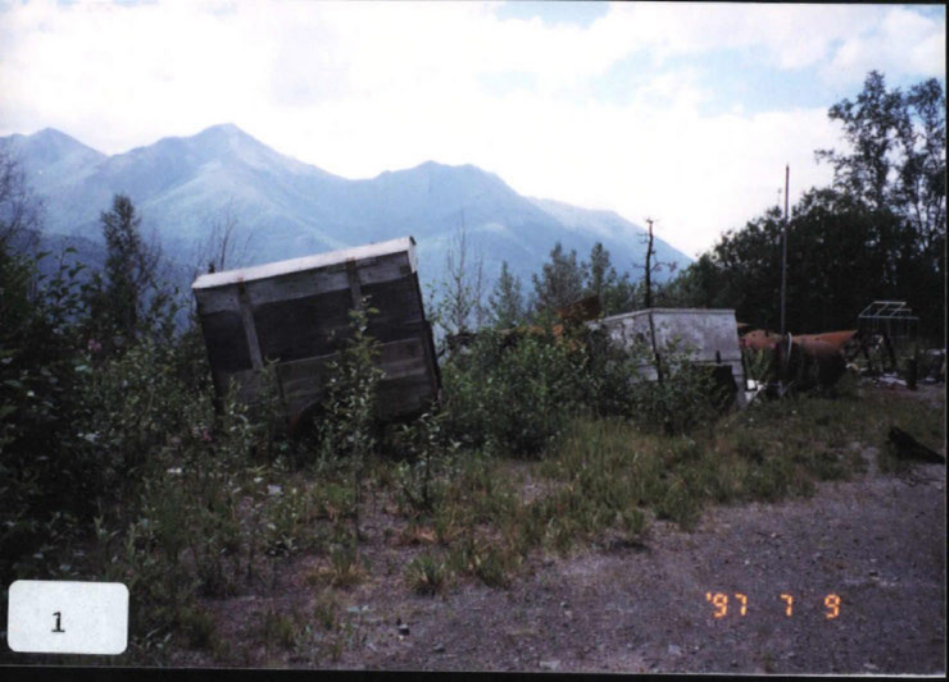
Photo No.	Date	Time	By	Description
1	7/9/97	1420	Zinza	Panoramic view of site from dirt access road; view Southwest
2	7/9/97	1420	Zinza	Panoramic view of site from dirt access road; view Southwest
3	7/9/97	1425	Zinza	Close-up of 55-gallon drum with military colors and markings; labelled dry cleaning solvent; manufacture date is 5/80
4	7/9/97	1427	Zinza	Aboveground storage tanks and burnt down quonset hut; view South
5	7/9/97	1430	Zinza	Stockpile of 10 empty 55-gallon drums; 6 have military markings (labels include dry cleaning solvent, methyl ethyl ketone, turbine fuel, and engine lube oil); 4 are blue and have Chevron jet fuel labels; view East
6	7/9/97	1434	Zinza	Burnt down quonset hut; view Northwest
7	7/9/97	1436	Zinza	Old (b) (6) station wagon; note mountainous slope above treeline in background; view Northeast
8	7/9/97	1439	Zinza	Wooden building (appears recent), wooden platform, greenhouse frame, and outhouse behind wooden building; view West

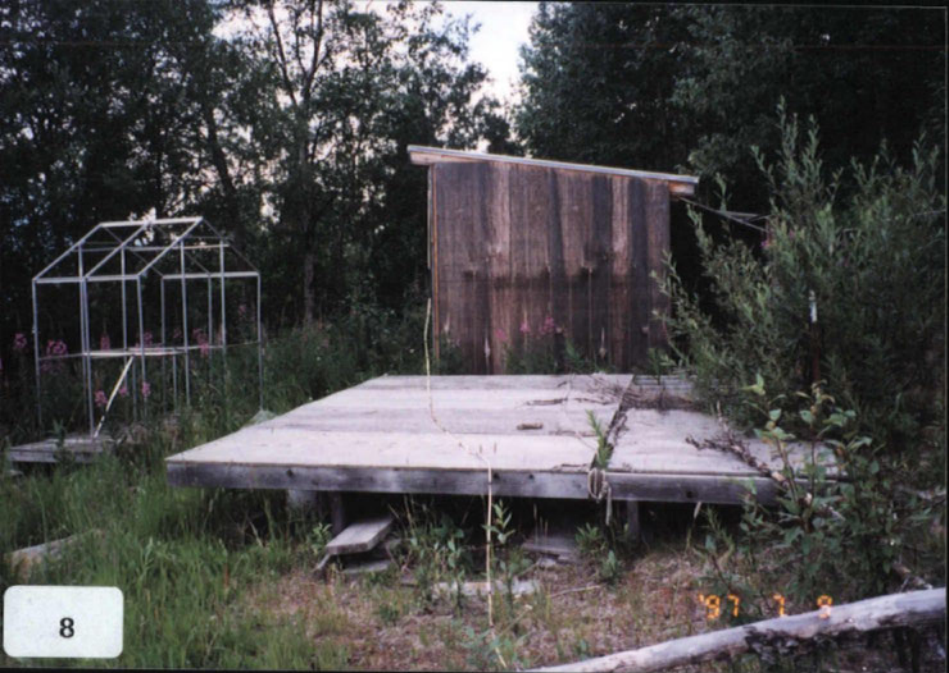
living compound. All drums were empty and no markings were discernable.

9	7/9/97	1449	Zinza	Empty drums found at the west side of the dirt road upslope from the main structures at the site; view Southeast
10	7/9/97	1449	Zinza	Empty drums found at the west side of the dirt road upslope from the main structures at the site; view Southeast

Based on the lack of documented release of hazardous constituents in site files, the lack of apparent contamination during the site visit, and information from site contacts indicating no on-site contamination, it appears no further action under the Comprehensive Environmental Response, Compensation and Liabilities Act (CERCLA) is warranted at this time. However, it is recommended that the current property owner, (b) (6), properly dispose of the 55-gallon drums on the property.
